FY99 Lessons Learned from Central Energy Plant Modernization Site Visits

by William T. Brown, Michael K. Brewer, Charles P. Marsh,
Vicki L. VanBlaricum, Gary E. Phetteplace, Martin J. Savoie,
Vincent F. Hock, Phil J. Conner, and Henry C. Gignilliat

November 2000

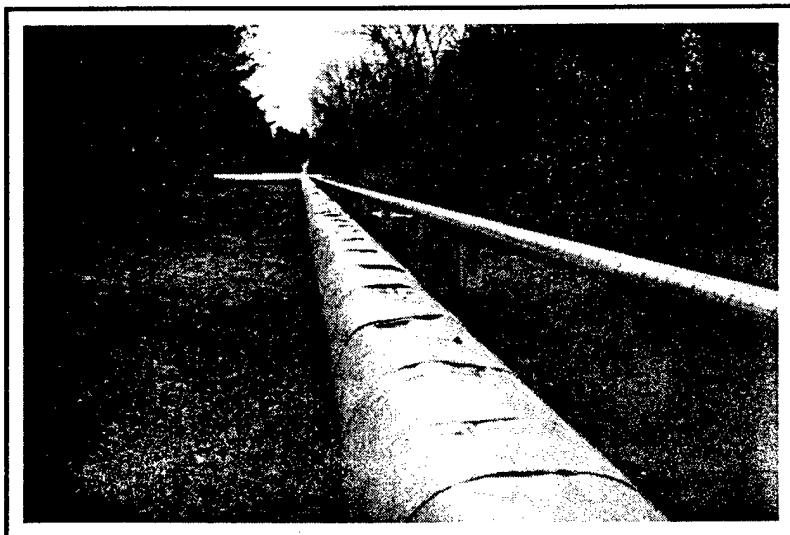
Figure 1. Steam distribution system lines.

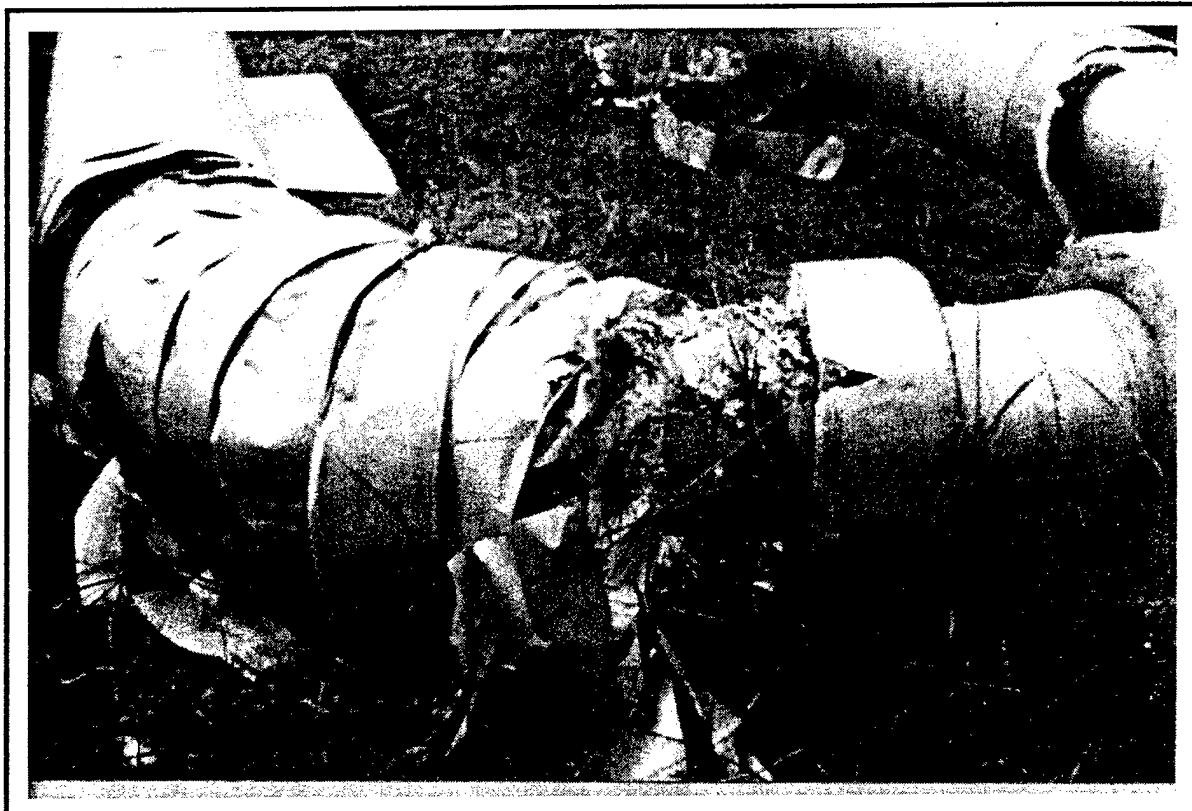
Figure 5. Steam distribution piping insulation and sheathing in poor condition.

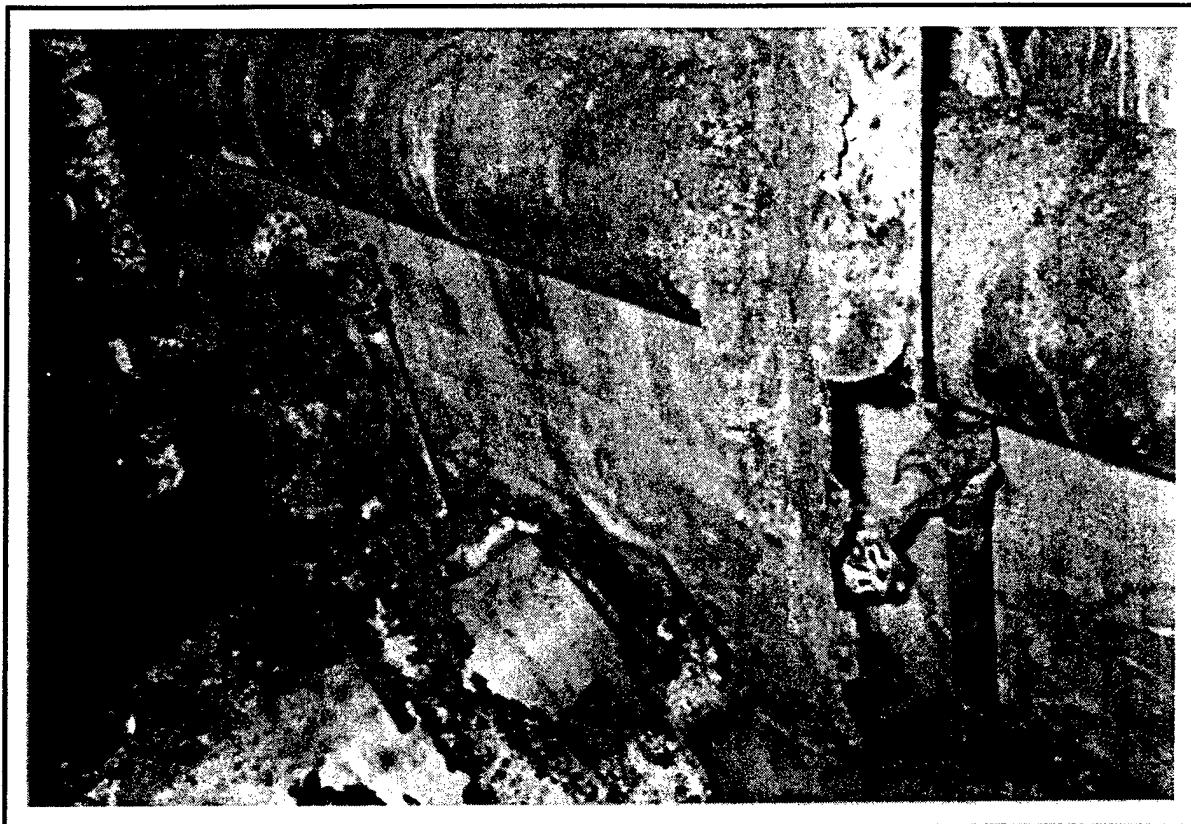
Several design deficiencies merit correction. The most dangerous were valves on vent piping (Figure 18). If a conduit is completely sealed off and there is a carrier leak, a dangerous situation can occur. The conduit piping is not designed to hold high pressures. The conduit vents should also be redone so as to not be manifolded together. Manifolding allows for a failure in one conduit to be transmitted into the next. In addition, the vent piping should be brought above grade so that any problems can be seen and corrected.

Figure 18. Corrosion scale and valved conduit in valve pit area.

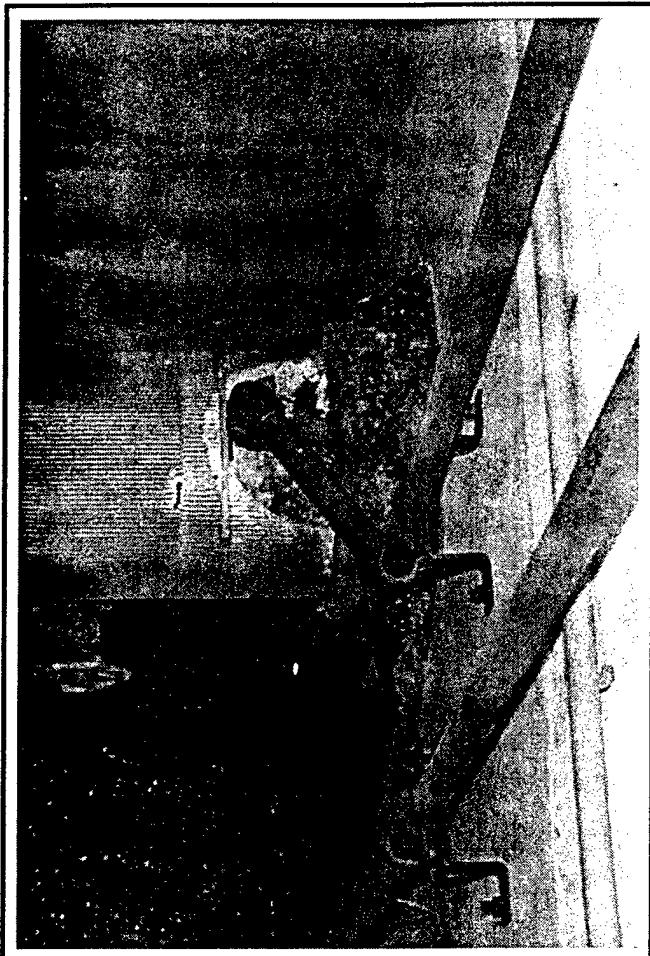
Figure 24. Casing corrosion in Fort Stewart valve pit outside Building 411.

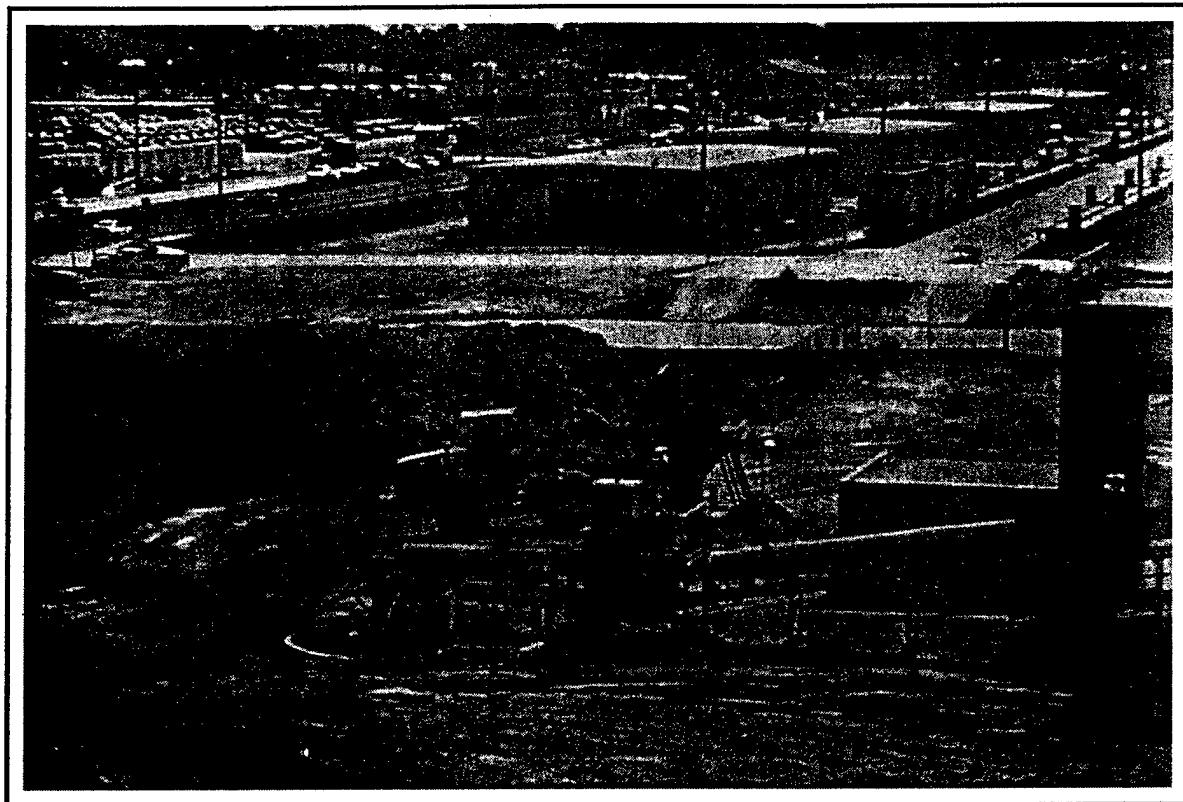
Figure 31. Wood supply area.
